MSC-04112

APOLLO 14 MISSION REPORT

MANNED SPACECRAFT CENTER

MAY 1971

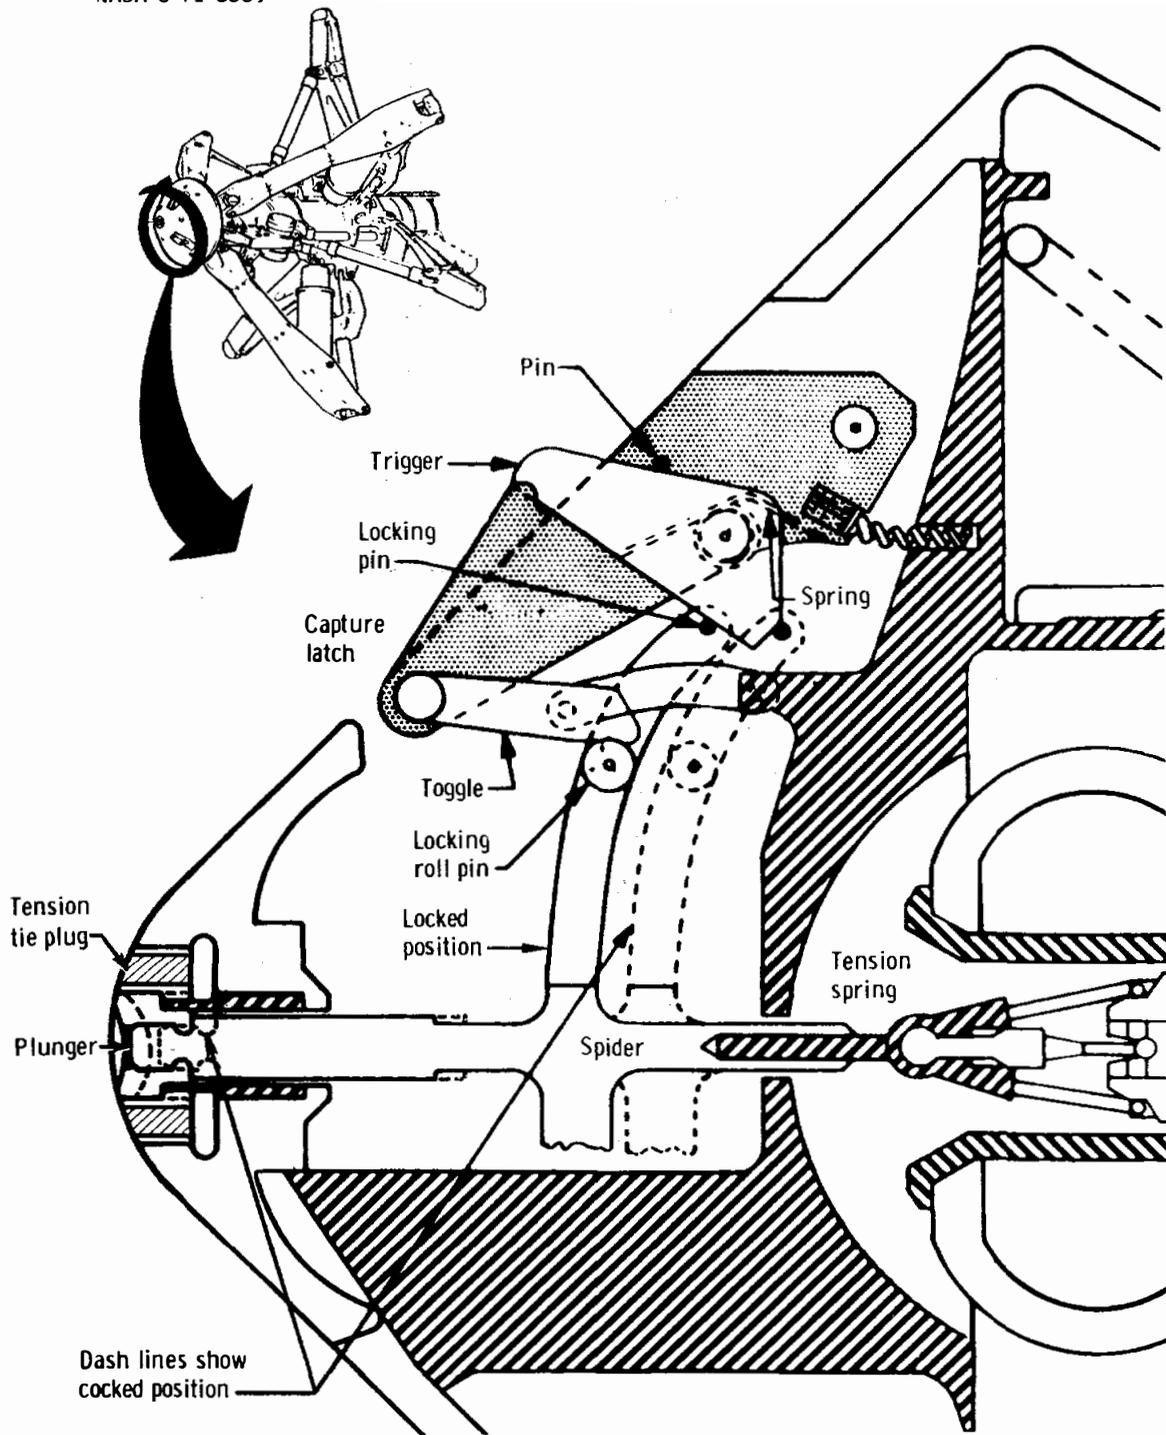
Figure 14-1.- Cross section of probe head and capture-latch assembly.

contamination or dimensional changes due to temperature. Internal damage to the capture-latch mechanism can be ruled out because the system functioned properly in all subsequent operations following the sixth docking attempt and during postflight testing.

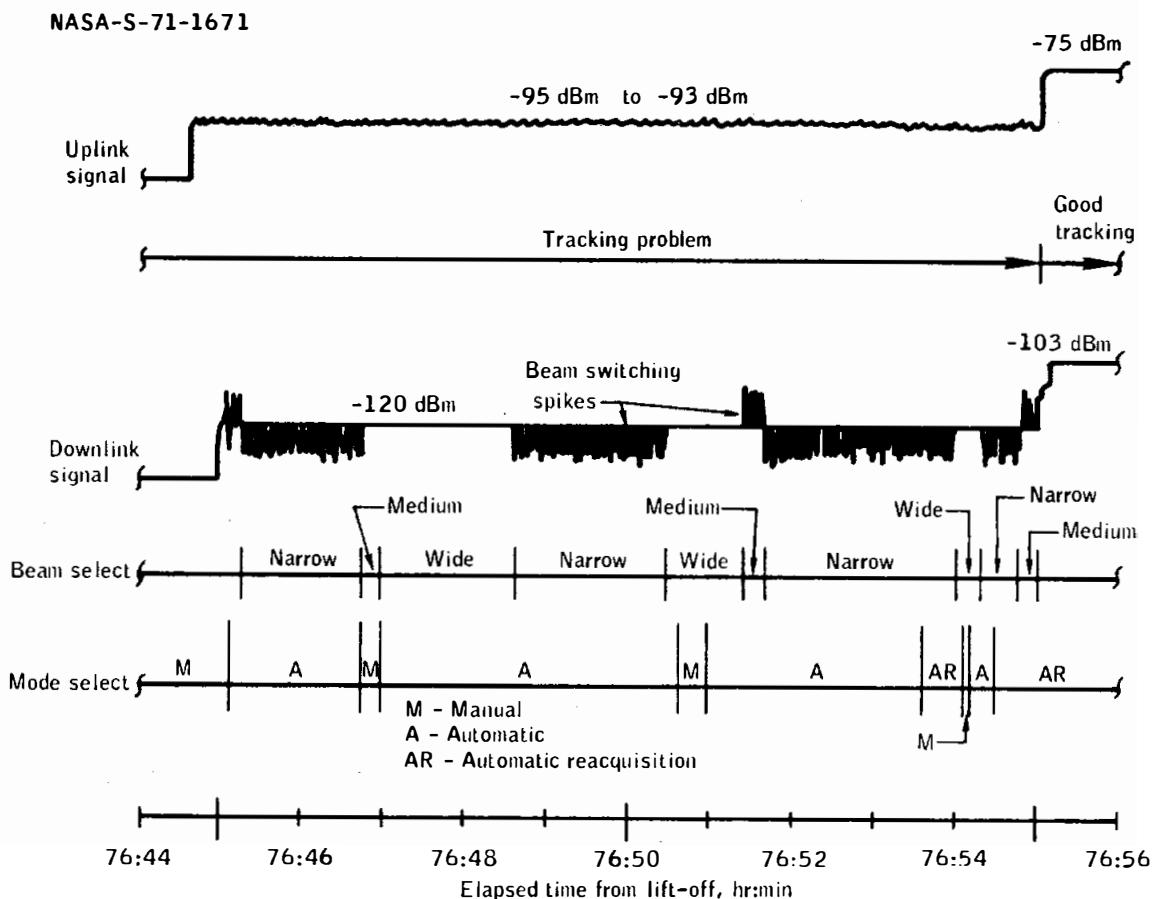
Figure 14-3.- Data from first period of anomalous operation.

The ground data signatures which show the first acquisition and tracking problems are illustrated in figure 14-3. The antenna started tracking a point approximately 5 to 8 degrees off the earth pointing angle at 76:45:00 elapsed time and continued tracking with low uplink and downlink signal levels for 10 minutes at which time a good narrow beam lock-up was achieved.

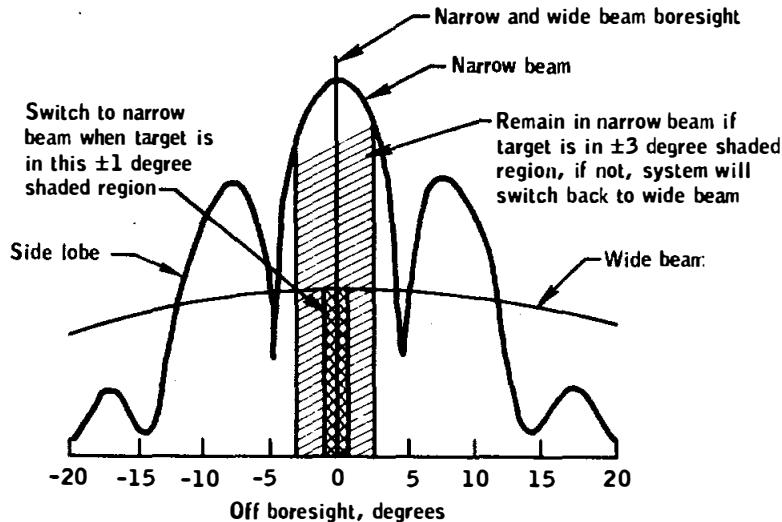
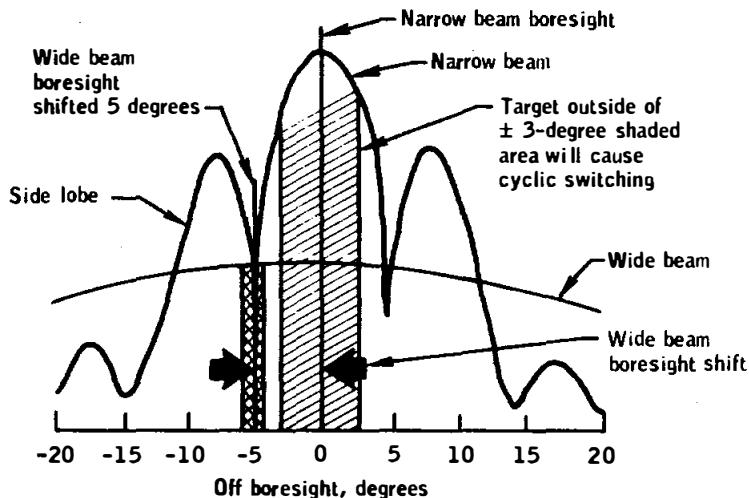
Figure 14-4.- Antenna narrow and wide beam boresight relationship.

The low signals correlate with antenna pattern and gain data for a 5- to 8-degree boresight shift in the wide-beam mode. The direction of the spikes observed on the downlink data in figure 14-3 are consistent with switching between the wide and narrow beams. Conditions for a normal alignment and a misalignment of the wide and narrow beams are shown in figure 14-4. A 5- to 8-degree shift in the wide-beam mode boresight

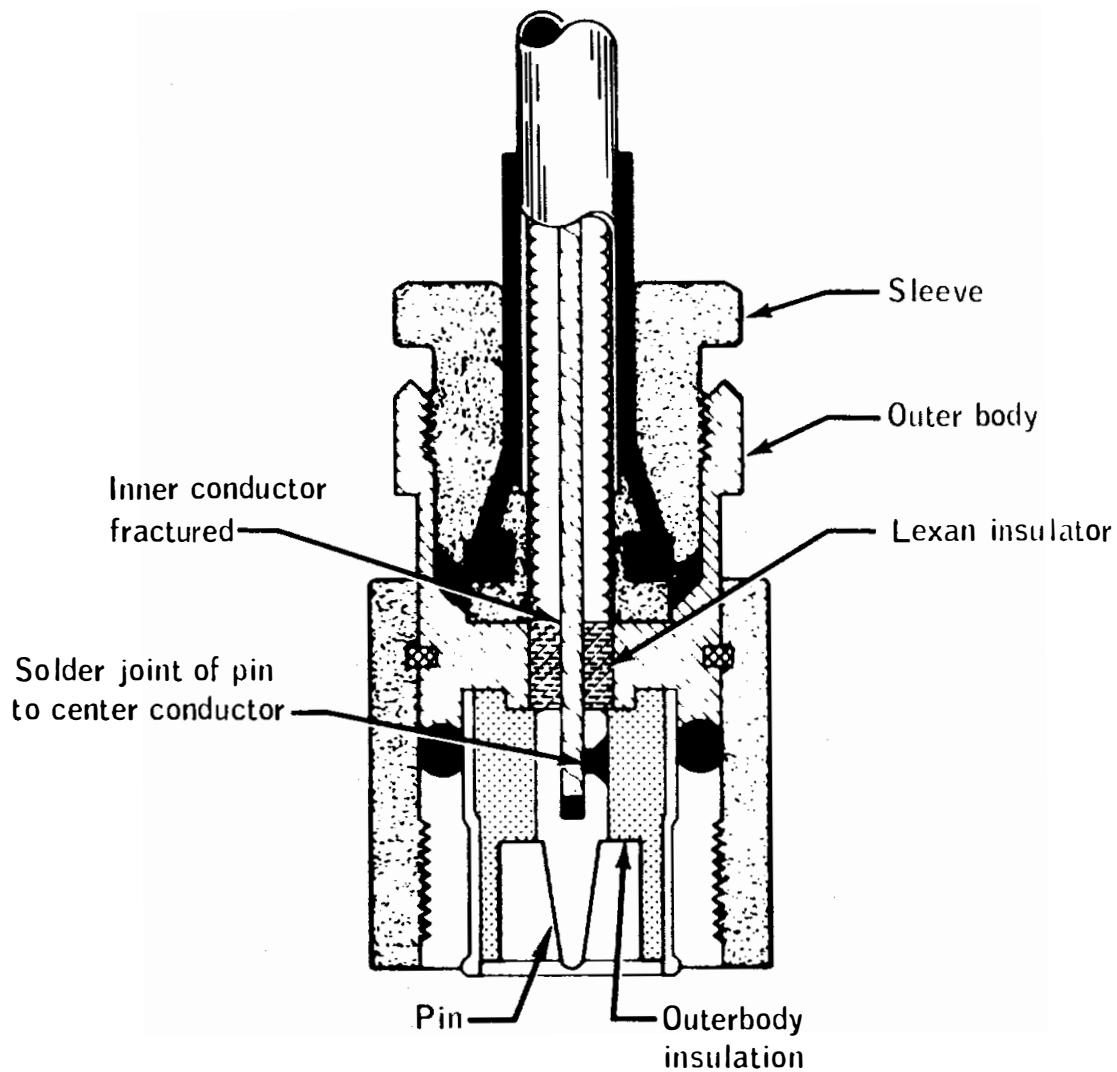
Figure 14-5.- Coaxial cable failures.

Note: A slip fit is required between the pin and insulator so that the pin does not rotate when turning outer body during assembly of the threaded sleeve.

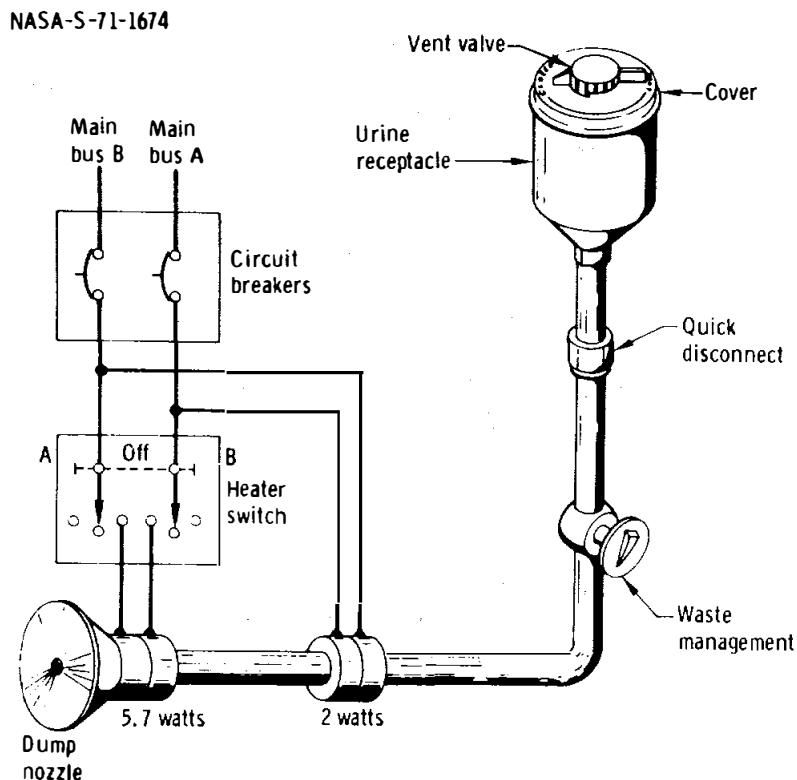
Figure 14-6.- Urine receptacle and nozzle.

After transposition and docking and prior to initiating passive thermal control, the crew indicated that the urine nozzle (fig. 14-6)

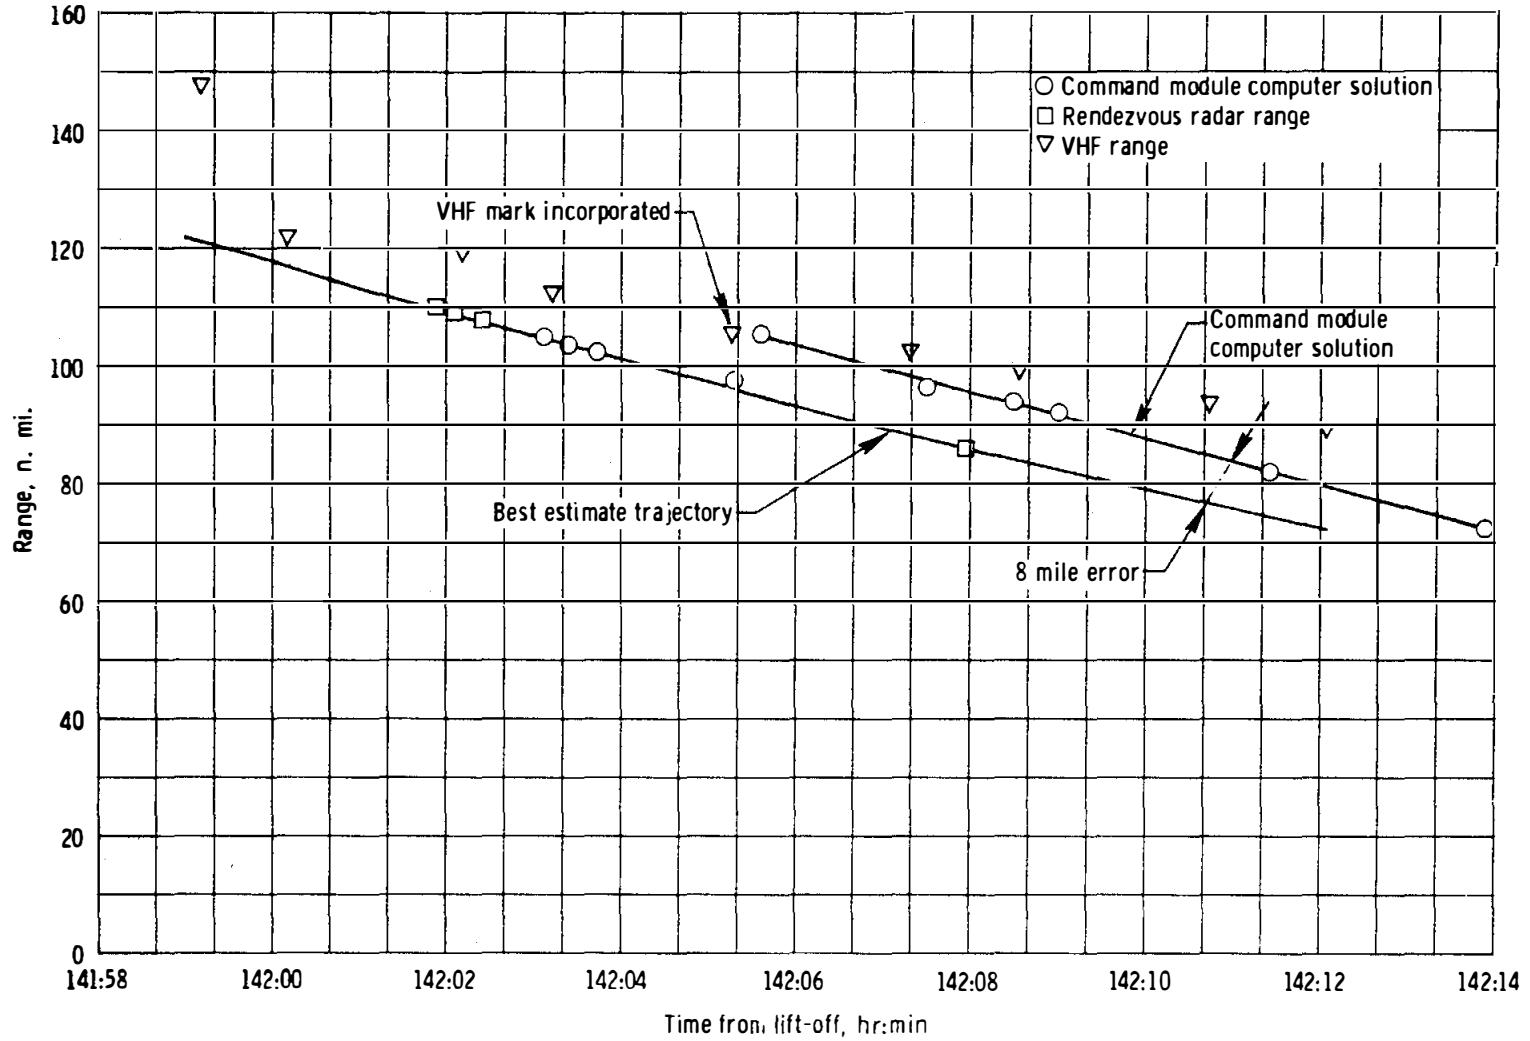
Figure 14-7.- Relative range comparisons during rendezvous.

Prior to lunar descent, the VHF ranging and rendezvous radar range measurements correlated closely. However, during the time period preceding terminal phase initiation, the VHF ranging system indicated erroneous measurements. During this same time period, numerous range tracking dropouts also occurred. The range measurements were in error by 5 to 15 miles when compared with the rendezvous radar range measurements (fig. 14-7). The VHF ranging data presented in the figure results from a number of different acquisitions. After terminal phase initiation, the

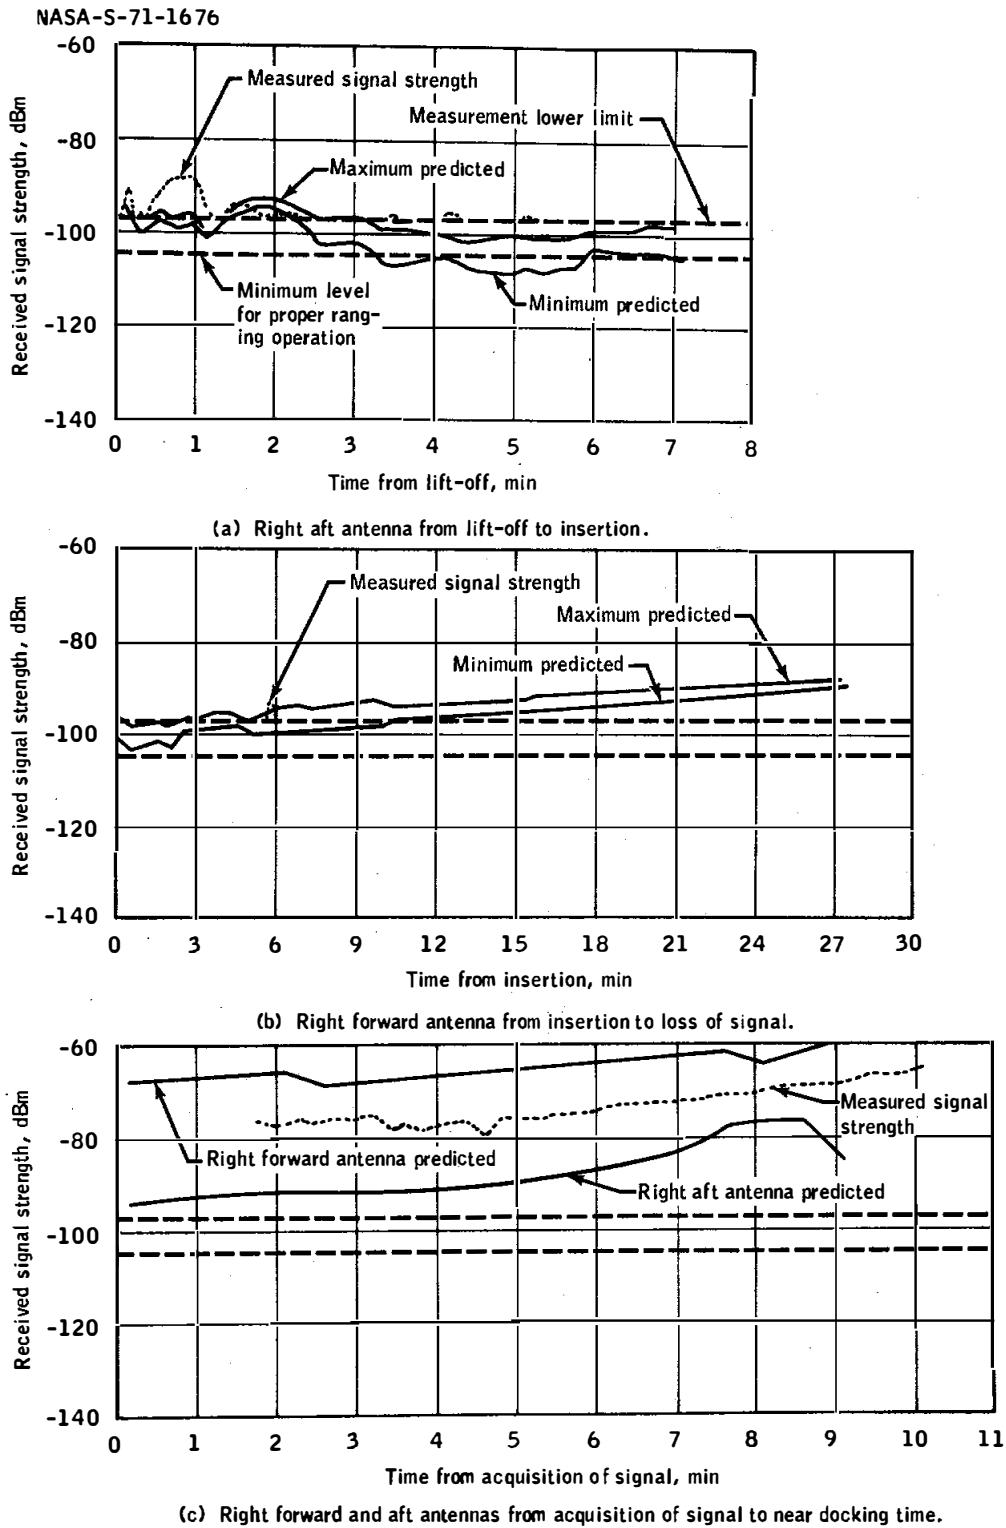
Figure 14-8.- Received signal strength from omnidirectional antennas.

The VHF ranging problems resulted from lower-than-normal signal strength together with the existing range rate. The ranging equipment is designed to operate with signal strengths greater than -105 dBm. The lunar module received signal strength data are essentially qualitative, since most of the inflight data during the problem period were off-scale low. Unfortunately, the scale selection was not chosen for failure analysis. A spot check of relative vehicle attitudes, as evidenced by normal performance of the rendezvous radar and by sextant sightings, indicates that the attitudes were proper. The crew also indicated that they followed the checklist for VHF antenna selection.

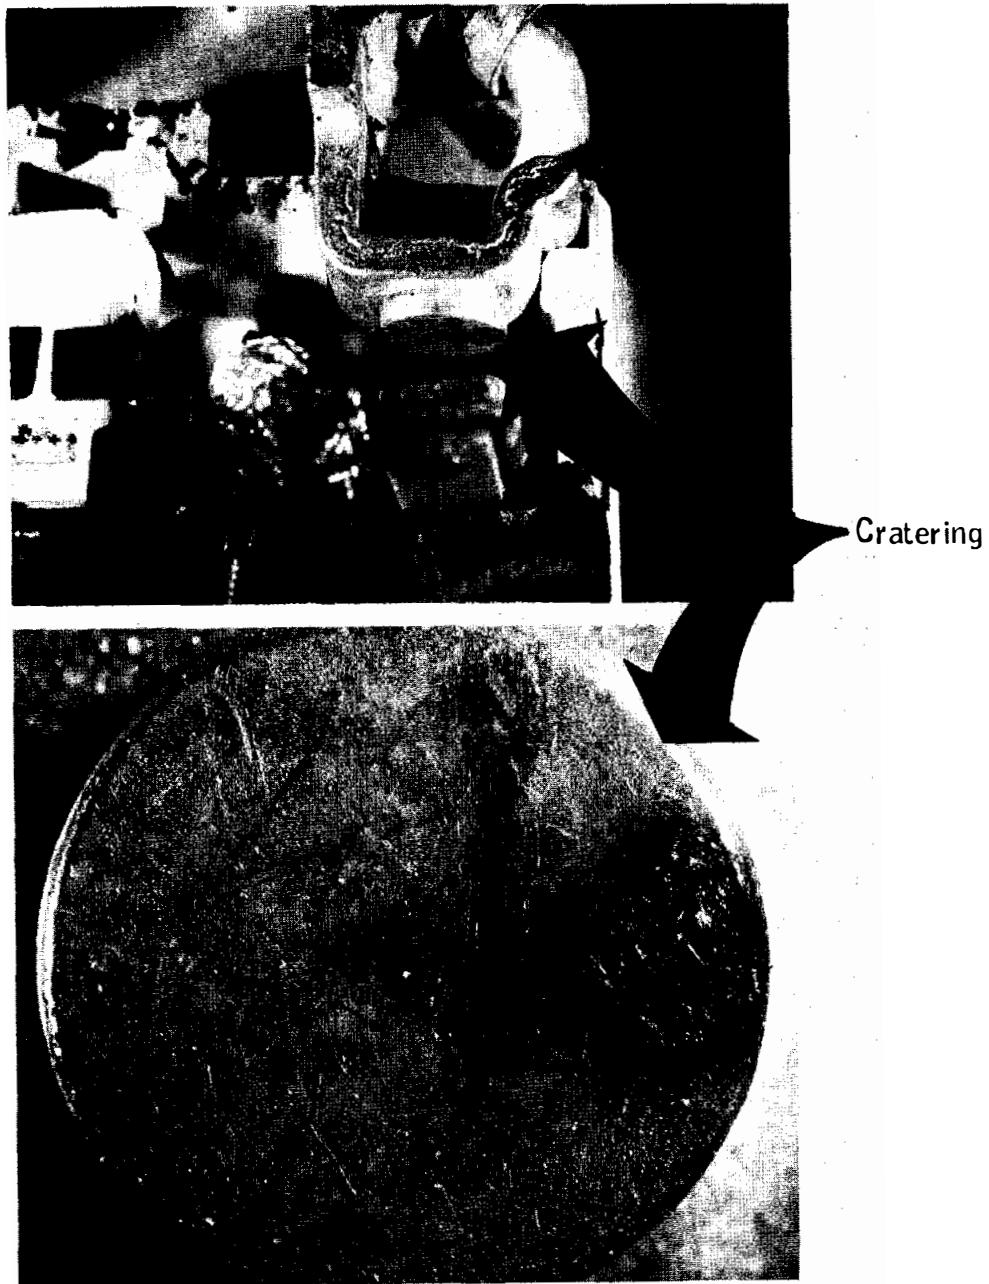
Figure 14-11.- Circuit breaker contact.

This anomaly is open.

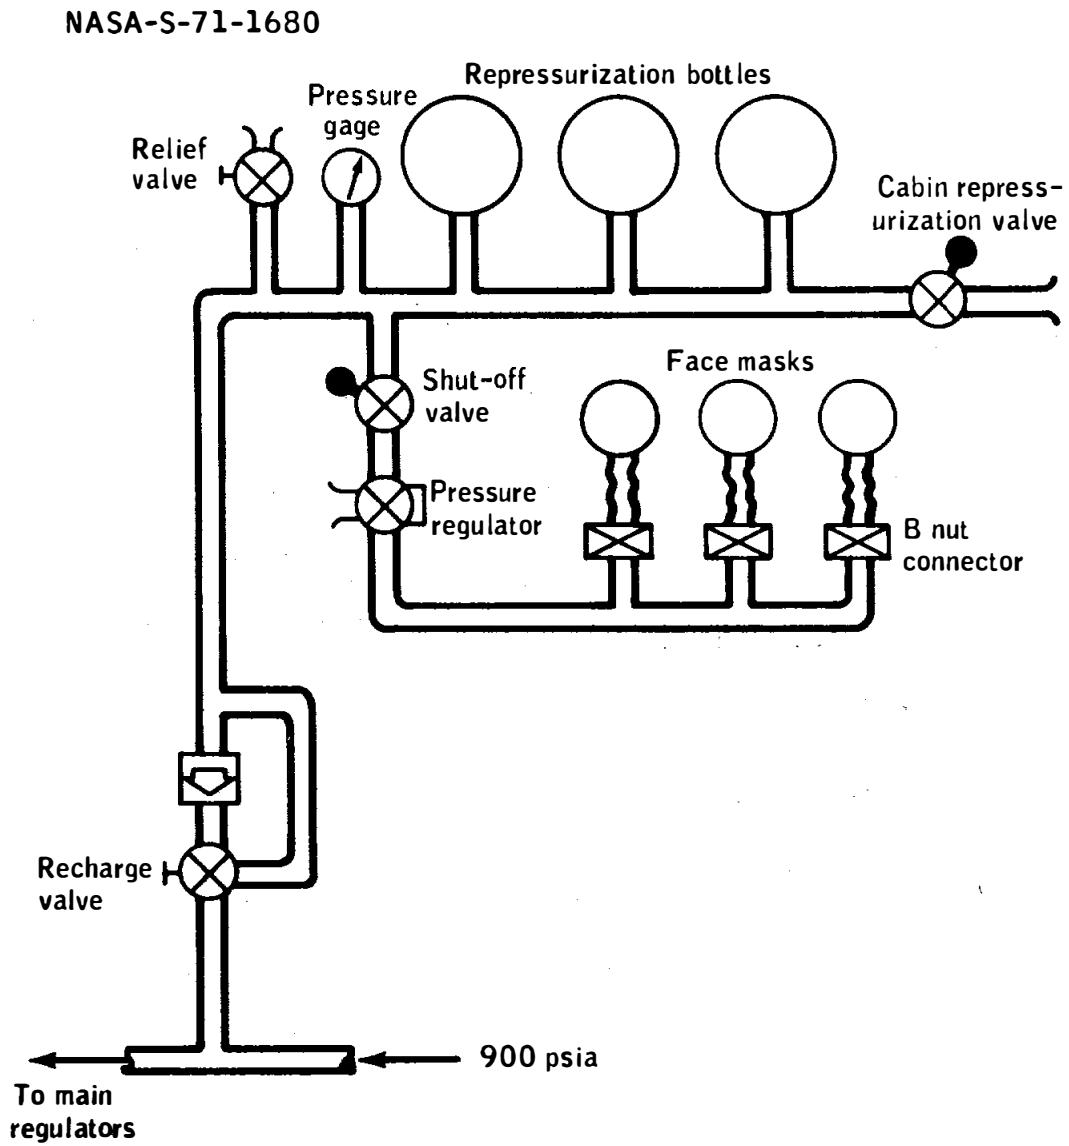
Figure 14-12.- Rapid repressurization system.

Repressurization of the three storage bottles in the rapid repressurization system (fig. 14-12) was required three times in addition to the normal repressurizations during the mission. The system required repressurization once in lunar orbit and twice during the transearth coast phase. Just prior to the first of the transearth coast repressurizations, the system had been used (face mask checks) and refilled (fig. 14-13). In this instance, the fill valve was closed before the system was fully recharged. Calculations from the surge tank pressure data indicate that the repressurization package was at approximately 510 psi at 199 hours 48 minutes and was only recharged to about 715 psi (fig. 14-13). The cabin indication of the repressurization package pressure would have indicated a higher pressure because of the temperature rise of the compressed gas. The crew noted a value of about 700 psi (due to temperature stabilization) at approximately 211 hours and recharged the system again.

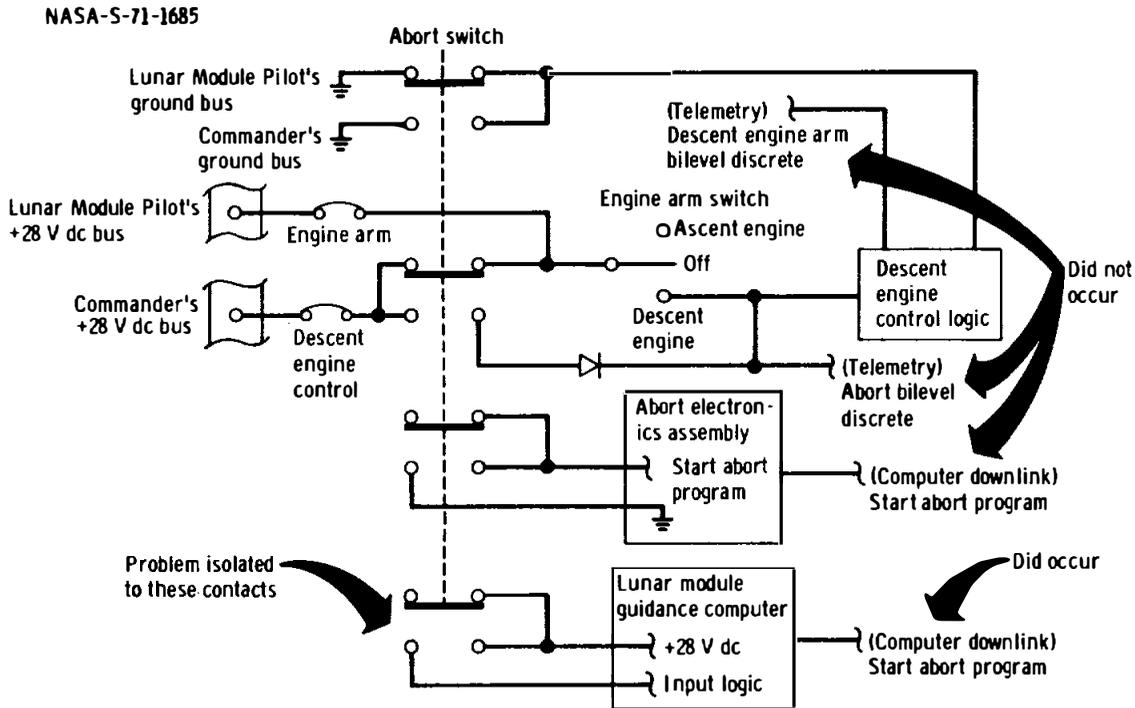
Figure 14-17.- Abort switch logic.

Prior to descent, the primary guidance computer received an abort command four different times. The computer would have reacted if the descent program had been initiated. The failure was isolated to one

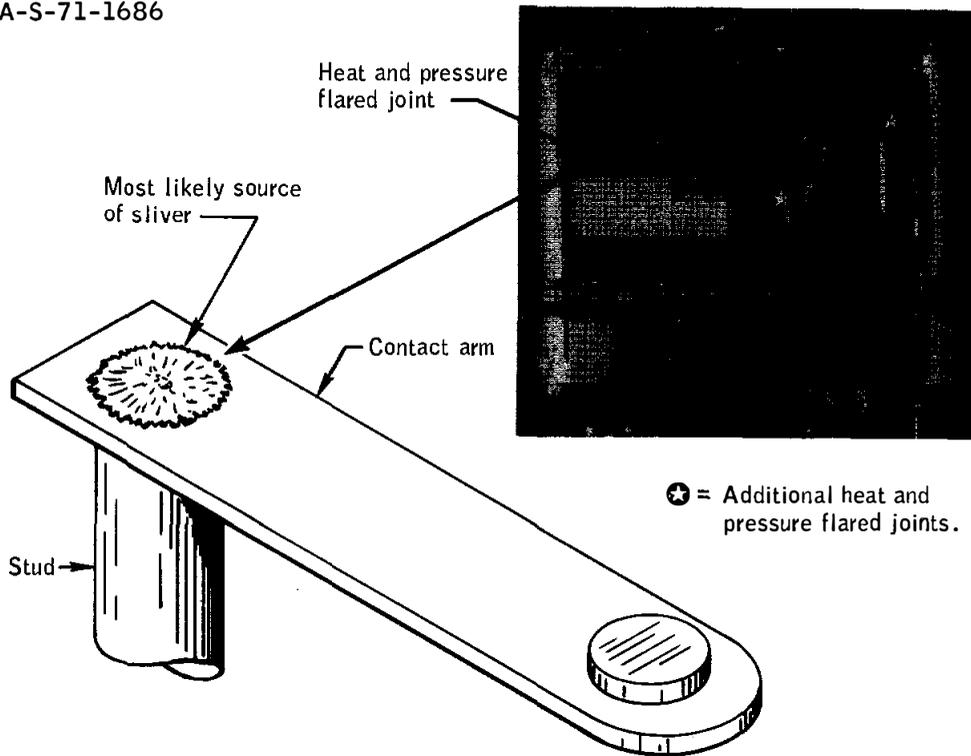
(a) Simplified sketch of internal switch parts.

Metal contamination up to 0.030-inch long slivers found in several switches

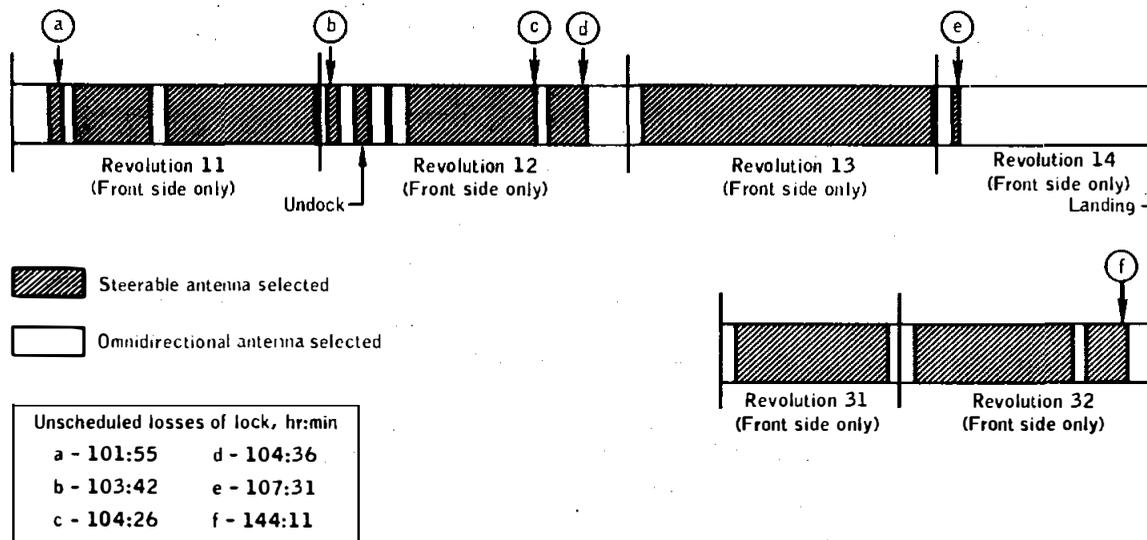
Figure 14-19.- S-band steerable antenna operation.

The remaining unexplained tracking interruptions (fig. 14-19) have similar characteristics. Five tracking interruptions occurred during Goldstone coverage and figure 14-20 is a plot of ground-station-received signal strengths at these times. During the Madrid ground station coverage of revolution 32, another incident was noted with the same type of

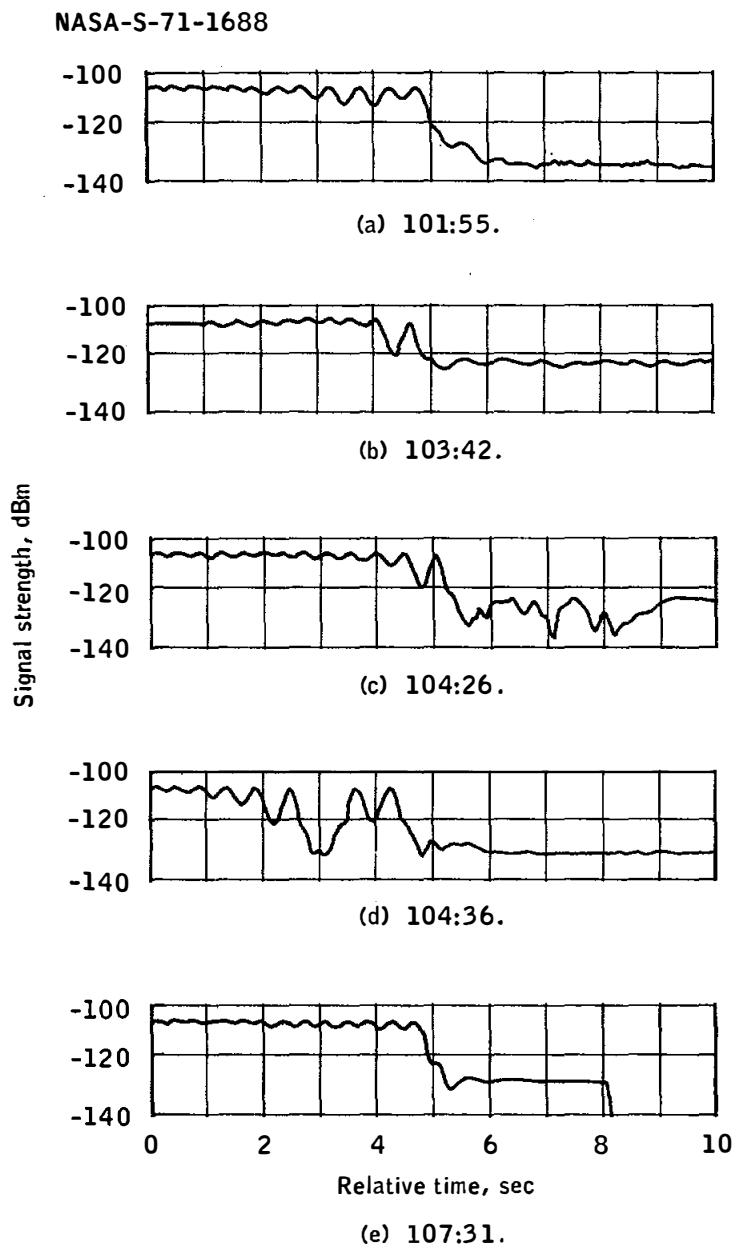
Figure 14-20.- Signal strength oscillations associated with five unexplained losses of lock.

Look-angle data indicate that the antenna was not pointed at or near the vehicle structure during the time periods when antenna lock was lost.

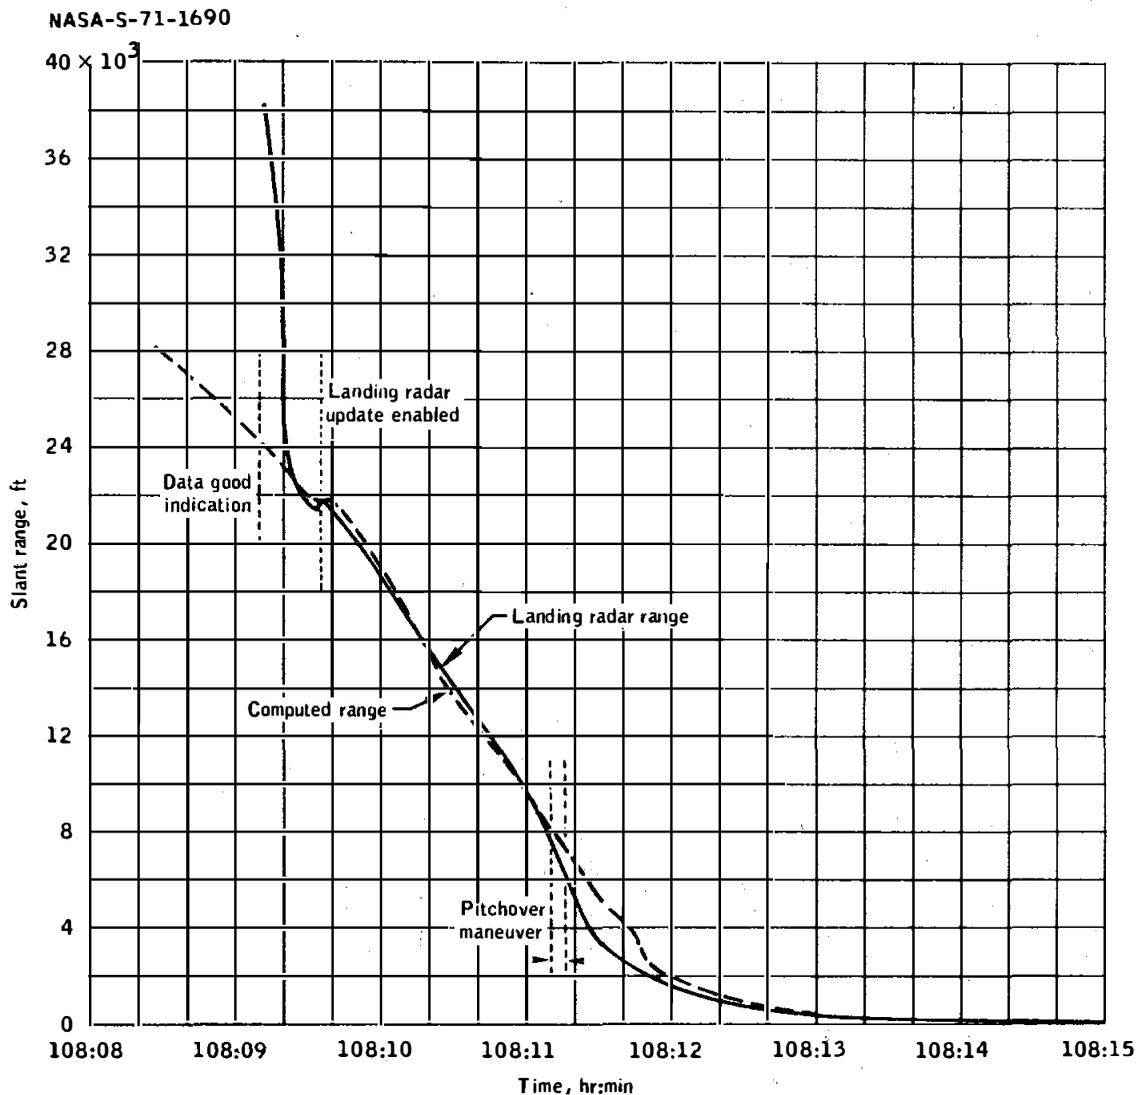
Figure 14-22.- Comparison of measured and computed slant range during powered descent.

The second condition which was not expected occurred after the circuit breaker was recycled. At this time the initial slant range reading was approximately 13 000 feet greater than that calculated from the operational trajectory. Several seconds later, the indicated slant range jumped from 32 000 to 25 000 feet. Subsequently, the landing radar readings compared favorably with the operational trajectory (fig. 14-22).

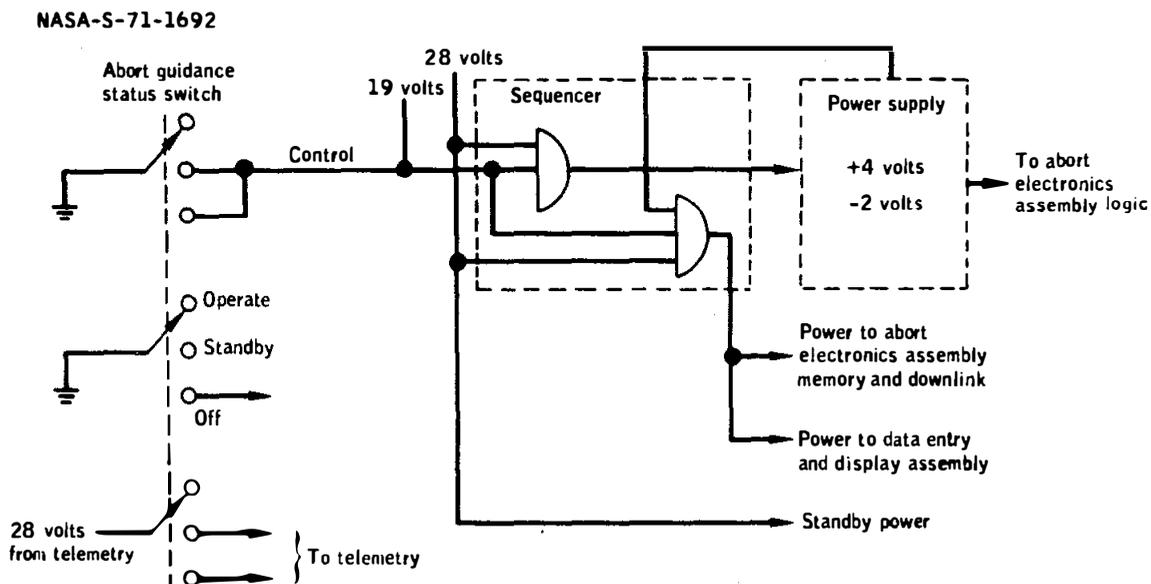
Figure 14-24.- Partial abort guidance system functional diagram.

The system was determined to have been in the standby mode after the failure by comparing expected and actual bus current changes that were observed at the time of the failure and the subsequent cycling of the circuit breakers. Further evidence of the system having been in standby was the absence of the warning light and master alarm at the time of the failure. If standby power in the electronics assembly were not maintained, clock pulses to the abort sensor assembly would have been lost and the warning light would have illuminated and the master alarm sounded. A warning light and a master alarm would also have occurred if the failure had been in the abort guidance status switch or the associated external wiring. These conditions isolate the failure to the power supply section or the sequencer of the abort electronics assembly (fig. 14-24).

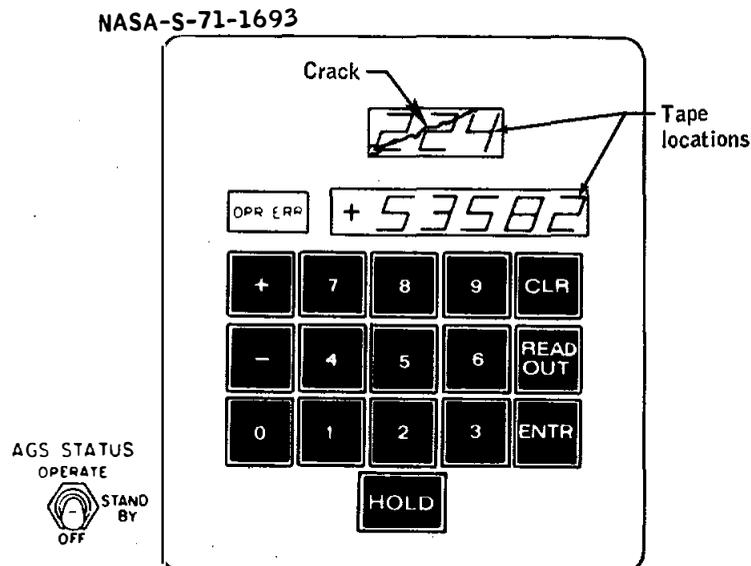
Figure 14-25.- Locations of crack and tape on data entry and display assembly.

The crew reported a crack in the glass across the address register of the data entry and display assembly. Figure 14-25 shows the assembly and the location of the crack. Figure 14-26 is an enlarged drawing of the glass and associated electroluminescent segments.

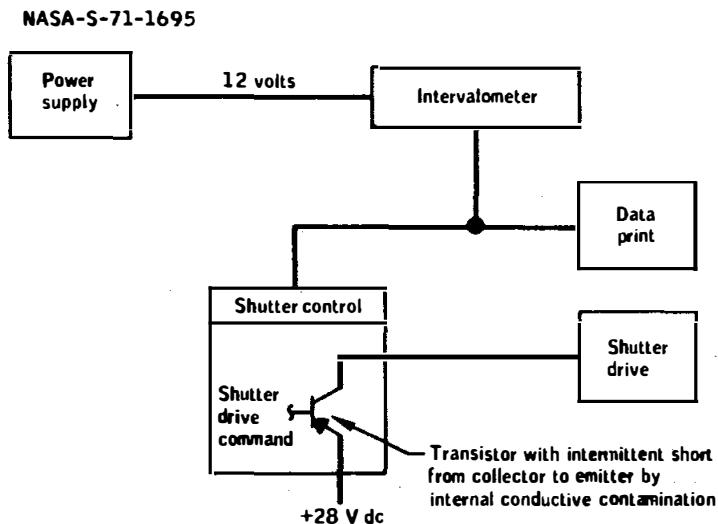
Figure 14-27.- Lunar topographic camera shutter control.

Postflight tests with the flight camera showed satisfactory operation in all simulated environments (pressure, thermal, and vibration) at one-g. An intermittent failure was found in a transistor in the shutter control circuit (fig. 14-27). The transistor was contaminated with a

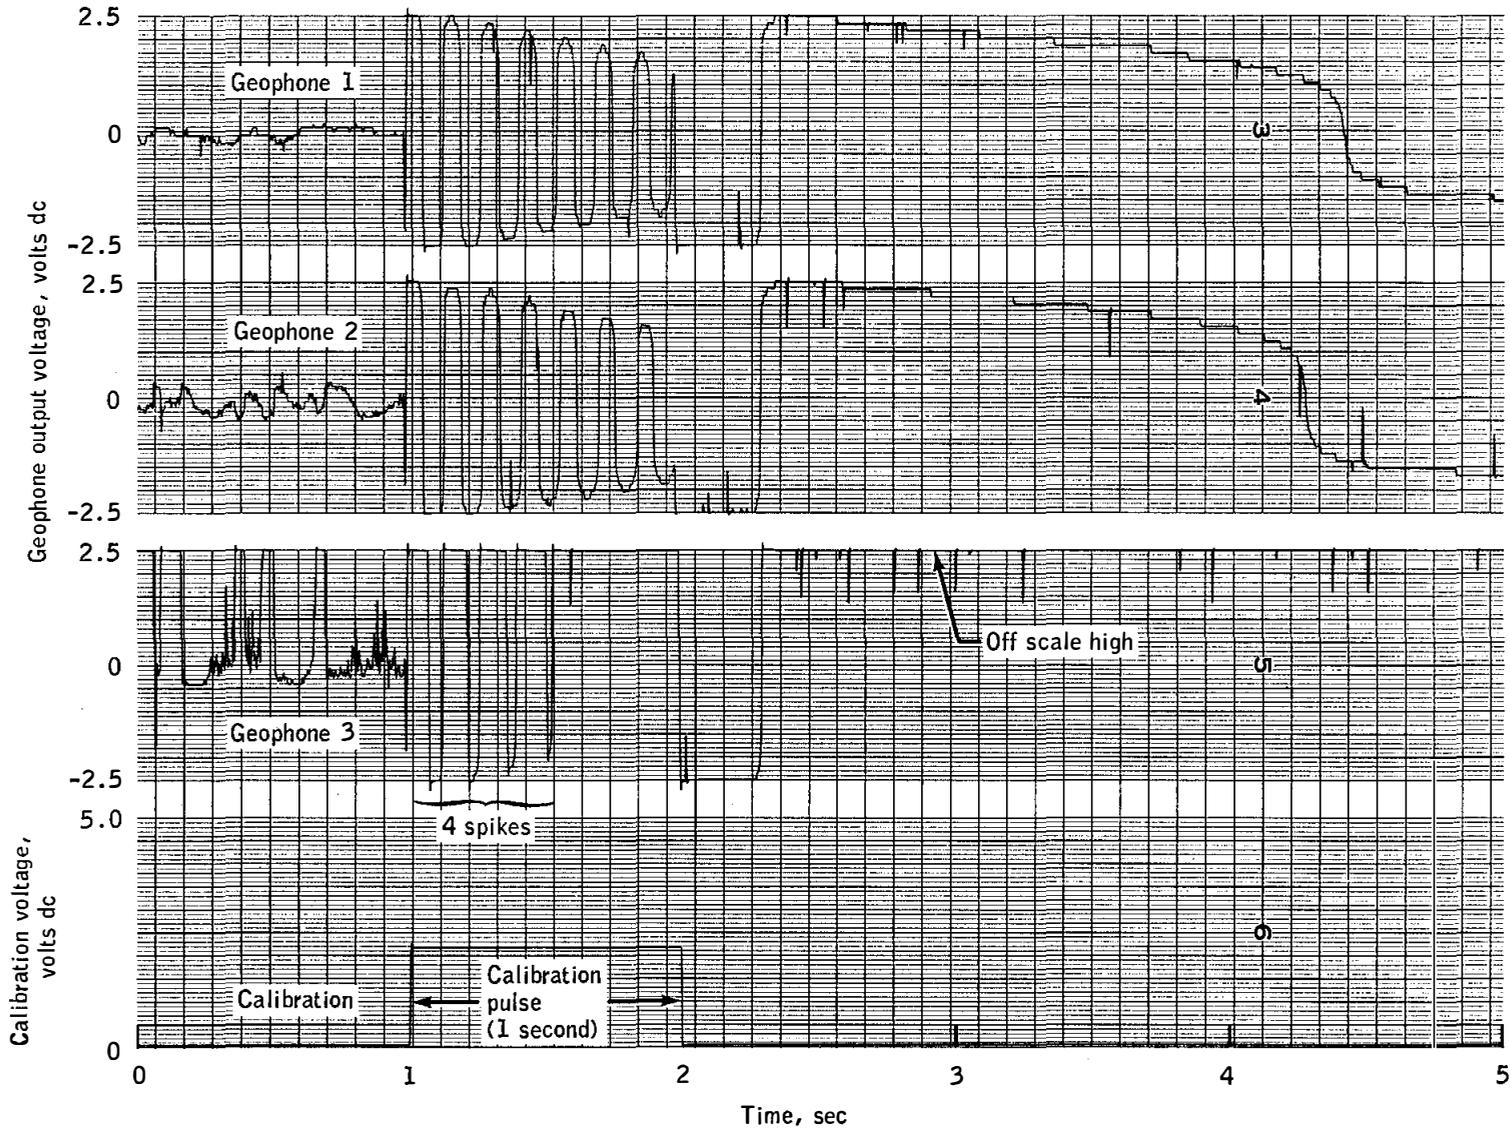
Figure 14-34.- Geophone calibration data.

The experiment was turned on in the listening mode on March 26, 1971, and geophone 3 data were spiking off-scale high (fig. 14-34). When the geophone channels were calibrated, the geophone 3 channel went off-scale high simultaneously with the start of the calibration pulse and stayed off-scale high for the remainder of the listening period. During the 1-second period when the calibration pulse was present, data from geophones 1 and 2 showed the normal 7-hertz ringing caused by the calibration pulse. However, geophone 3 data showed four negative-going spikes coincident with the first four negative half cycles of the ringing on the other two channels. The spikes decreased in duration from the first to the last, the last having an amplitude of 90 percent of
